#### AN ENCOUNTER WITH DISRUPTION OF KK LINE TRAFFIC BY NAXALITIES

## SALVAGING OF A DIESEL LOCOMOTIVE FROM CRITICAL CONDITION AT KAPILASH ROAD/ KUR DIV./ E.CO.R USING C.C.CRIBS AND HRE

# AN ENCOUNTER WITH DISRUPTION OF KK LINE TRAFFIC BY NAXALITIES (PART-II)

#### Dayanand Sahu, Sr. DME/WAT

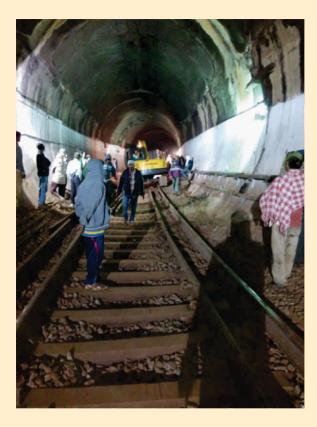
FIR received at 5:40 hrs and ART/KRDL, ART/KRPU and 120T Diesel Crane alongwith ART of VSKP ordered immediately. ART/KRPU reached the site at 8:30 hrs and rerailed the 46<sup>th</sup> wagon from Engine at 10:50 hrs, 47<sup>th</sup> wagon from engine at 12:15 hrs and 48<sup>th</sup> wagon from engine at 13:45 hrs. ART along with three rerailed wagons and two wagons were sent back to JRT at 15:00 hrs.

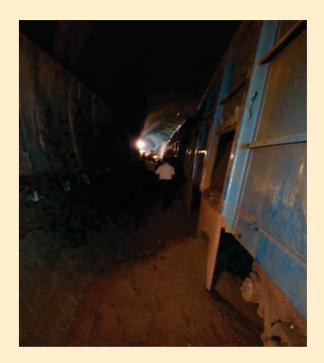
In the meanwhile, ART/KRDL reached to the site at 15:55 hrs., however required to wait till 19:10 hrs for track related work at 20:25 hrs. Then 56<sup>th</sup> wagon was rerailed by MFD/KRDL locomotive at KRPU end. Again, site was allowed for temporary track linking up to 21:35. Wagon lifted at 22:20 hrs after which track under the lifted trolley continued up to 00:50 hrs. The 55<sup>th</sup> wagon leading trolley rerailed at 1:15 hrs and pulled ahead at rear trolley rerailed at 2:45 hrs.

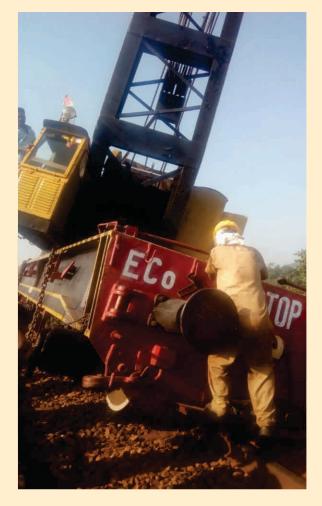
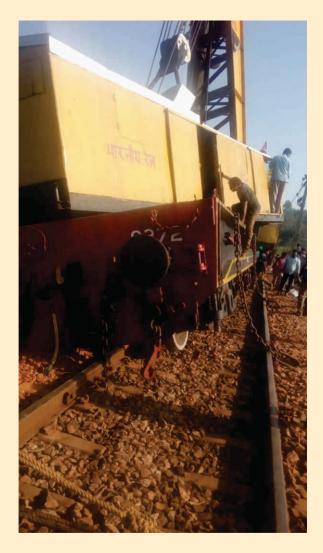
While placing the old girder, propping was done, however, fresh propping were required for making way for 180 degree slewing for the new girder. With two prop in position, it was assumed that it would safely handle the load of 16 T girder. However, as per statement of the crane driver, when he was just trying to slew the crane, the farther girder prop failed and the crane tilted rightside causing the New girder to sway which could not be controlled.

It is further found that, the propping at farther end of the load has failed while the nearer one remained intact. This may happen either due to excess load coming to the farther prop or less reaction generated by it. From the position of the load, it is clear that, normally more load shall be subjected to the nearer prop than the farther prop. This suggests that the support from formation below the packing was not adequate enough to take the load which has resulted in failure of the prop.

It is also found that safety clamps were not fixed to the rails, which could have provided safety in case of failure of prop, thus allowing the 120T crane to derail.

Thus, inadequate propping, non provision of safety clamps alongwith sudden sinking of prop base have caused the derailment of the Crane.
